SECTION C

PROPELLER SHAFT ALL SERIES

Division	Subject	Paragraph
I	TRUBLE DIAGNOSIS: Propeller Shaft Trouble Diagnosis	40-25
II	DESCRIPTION AND OPERATION: Description of Propeller Shaft	40-26
III	ADJUSTMENTS AND MINOR SERVICE: Checking Rear Universal Joint Angle	40-27
	Checking Propeller Shaft Run-Out	40-28
	Propeller Shaft Balancing Procedure	40-29
IV	REMOVAL AND INSTALLATION: Removal of Propeller Shaft	40-30
	Installation of Propeller Shaft	40-31
V	OVERHAUL AND MAJOR SERVICE: Disassembly of Propeller Shaft	40-32
	Assembly of Propeller Shaft	40-33
VI	SPECIFICATIONS: Propeller Shaft Specifications	40-34
		40C-1

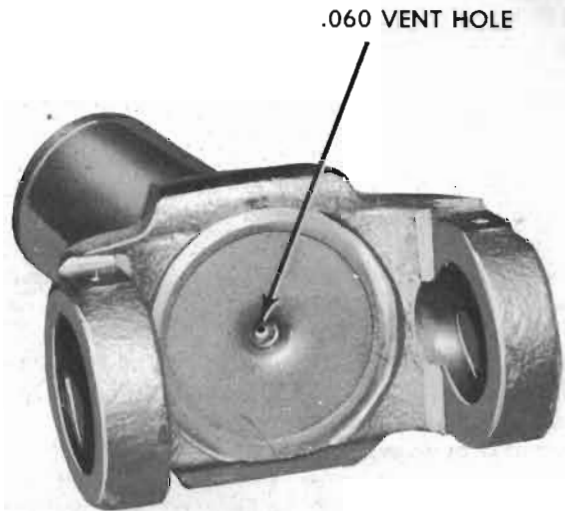
Figure 40-50 - Slip Yoke With Vent Hole

yoke spline is lubricated with grease and provided with a small vent hole to prevent "blowing" the o-ring seal during installation. These slip yokes should be inspected to be sure the vent hole is clear. See Figure 40-50.

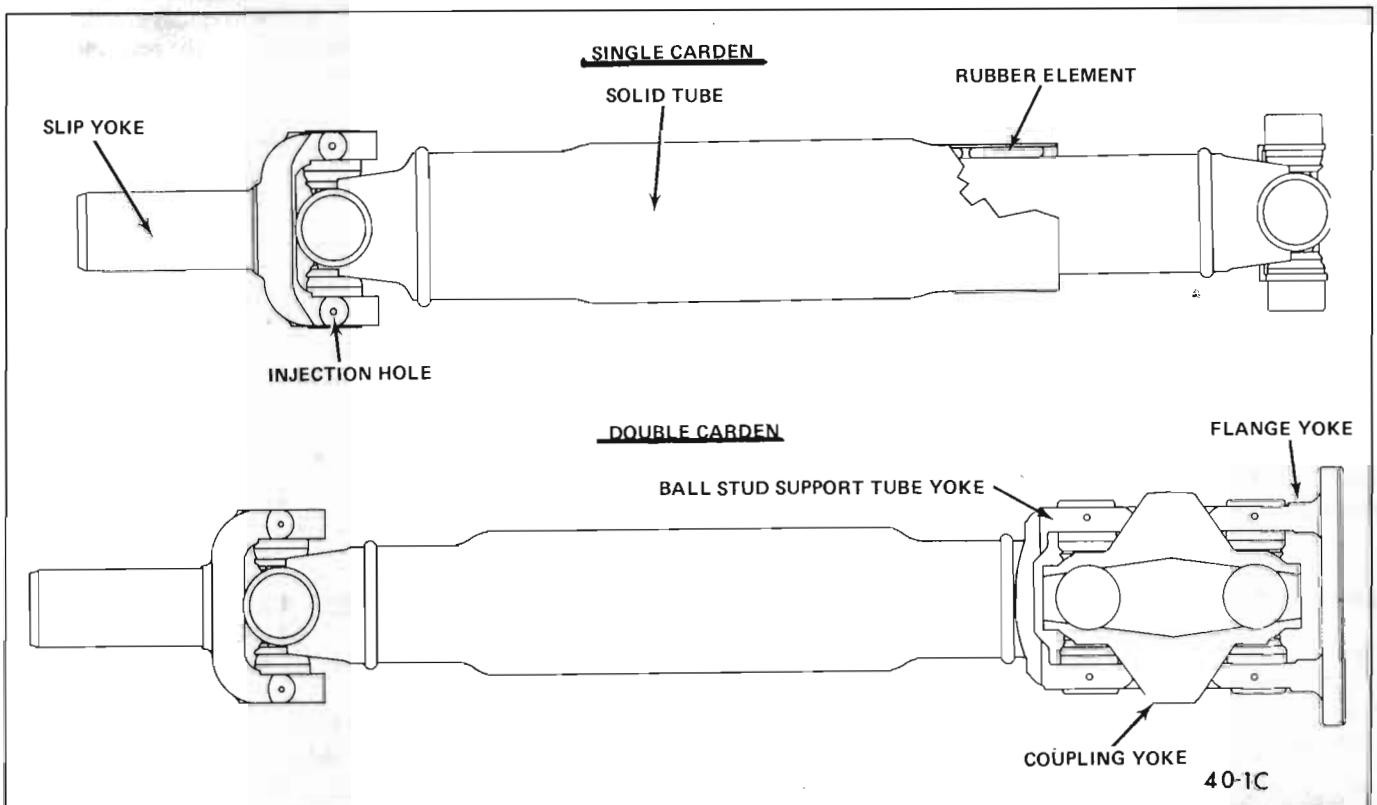
Figure 40-49 - Propeller Shaft Assemblies

Power is transmitted from the transmission output shaft to the differential by either one of two type propeller shaft assemblies: One type used on the 43- 44000 and Estate Wagons is a one-piece shaft with two cardan universal joints. The other type used on 45- 46-48 and 49000 (less Estate Wagons) also has a one-piece propeller shaft but has a cardan universal joint in the front and a double cardan universal joint at the rear. See Figure 40-49.

The propeller shaft used on 43-44000 and Estate Wagons is made up of concentric steel tubes with rubber elements between. See Figure 40-49.

Each shaft is installed in the same manner. A universal joint and splined slip yoke are located at the transmission end of the shaft, where they are held in alignment by a bushing in the transmission rear extension. The slip yoke permits fore and aft movement of the drive shaft, as the differential assembly moves up and down. The spline is lubricated internally by transmission lubricant or grease. An oil seal at the transmission prevents leakage and protects the slip yoke from dust, dirt, and other harmful material. On cars with automatic transmissions, the slip

The propeller shaft used on 45-46-48 and 49000 is similar to the type used on 43-44000 and Estate Wagons, except for the double cardan universal joint at the rear.

This joint consists of two cardan joints, closely coupled with a link yoke.

A centering ball socket between the joints maintains the relative position of the two units. This centering device causes each of the two units to operate through one-half of the complete angle between the drive shaft and differential carrier.

This drive shaft is attached to the differential carrier by means of a double flange connection. A flange on the rear universal joint is attached to a flange on the differential carrier pinion by four screws and bolts.

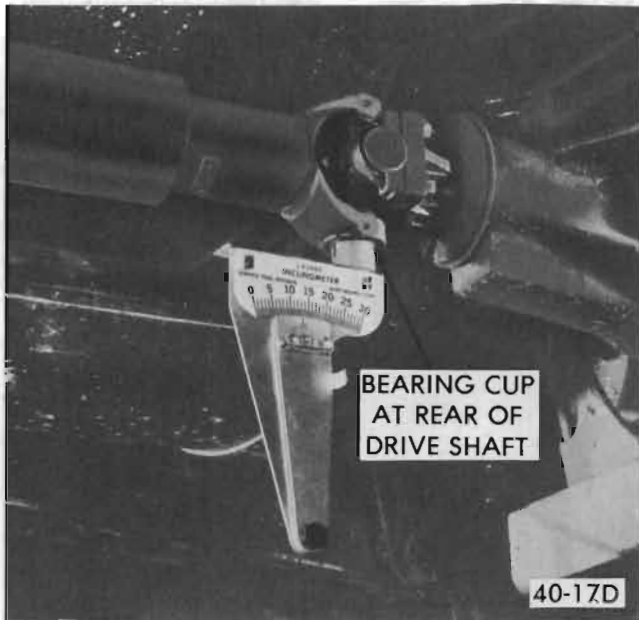
Figure 40-51 Measuring Angle at Rear of Propeller Shaft

1. Place inclinometer on rear propeller shaft bearing cap. See Figure 40-51. Center bubble in sight glass and record measurement.

CAUTION: *Bearing cap must be straight up and down and free of dirt or other foreign material to obtain an accurate measurement.*

3. Add both figures to obtain existing rear joint angle.

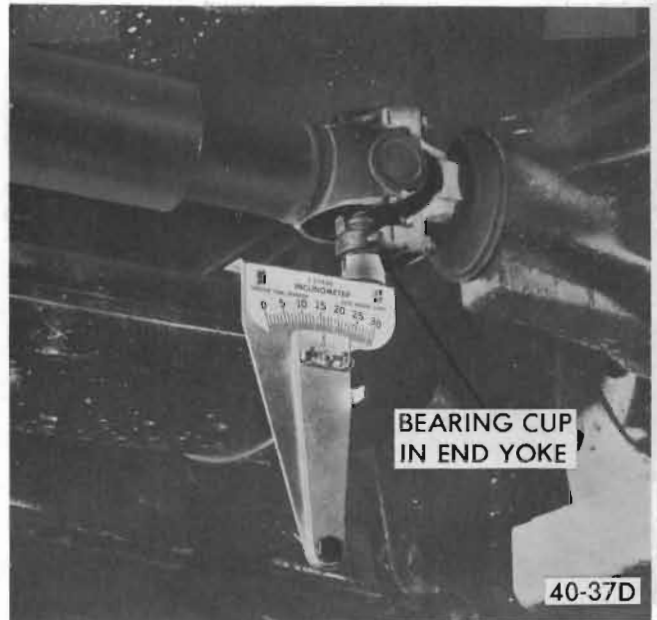
Figure 40-52 Measuring Angle at Rear of Propeller Shaft

ter on rear drive yoke bearing cap. See Figure 40-52. Center bubble in sight glass and record measurement.

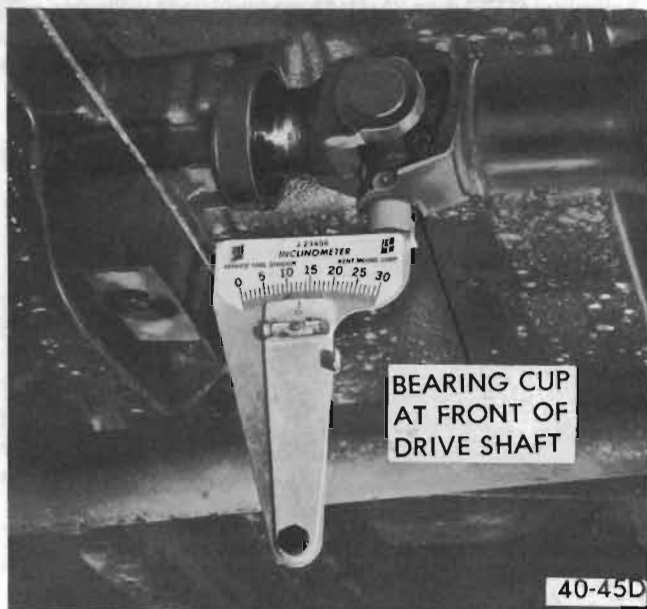
Figure 40-54 Measuring Angle at Front of Propeller Shaft

1. Place inclinometer on front propeller shaft bearing cap.

See Figure 40-54. Center bubble in sight and record measurement.

3. Subtract smaller figure from larger figure to obtain existing front universal joint angle.

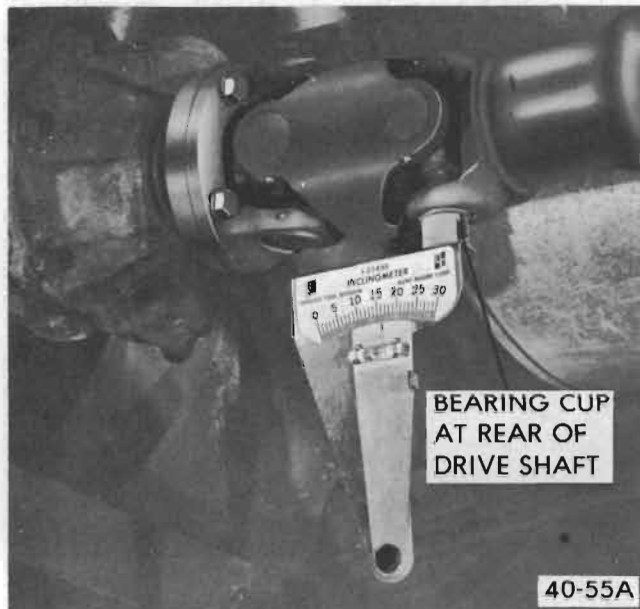
Figure 40-55A - Measuring Angle at Rear of Propeller Shaft

1. Place inclinometer on rear drive shaft bearing cup. See Figure 40-55A. Center bubble in sight glass and record angle.

3. Add both figures to obtain rear joint angle.

NOTE: When measuring the angle of any double cardan joint, the inclinometer measurements are made on the faces of the bearing cups joining the two shafts or shaft and flange yoke to the two crosses. Do not measure on the bearing cups on the coupling yoke. Rotate the drive shaft so that the bearing cups to be measured are in the straight up and down position. Measurements must be made on the clean metal face of the bearing cup ends.

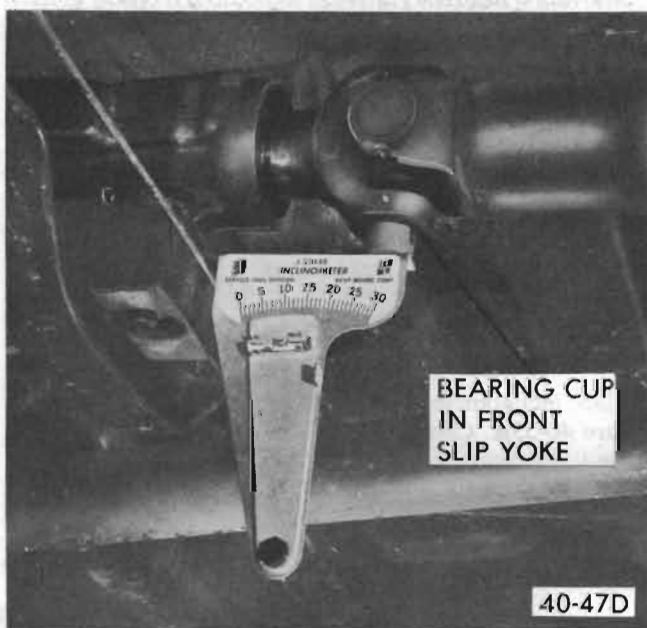
Figure 40-55 Measuring Angle at Front of Propeller Shaft

2. Rotate propeller shaft 90 degrees and place inclinometer on front slip spline yoke bearing car. See Figure 40-55. Center bubble on sight glass and record measurement.

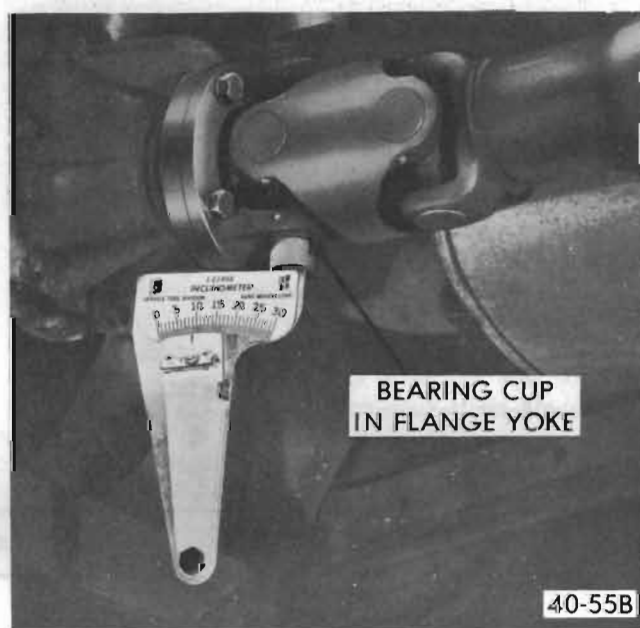
Figure 40-55B - Measuring Angle at Rear of Propeller Shaft

2. Place inclinometer on rear flange yoke bearing cup. See Figure 40-55B. Center bubble in sight glass and record angle.

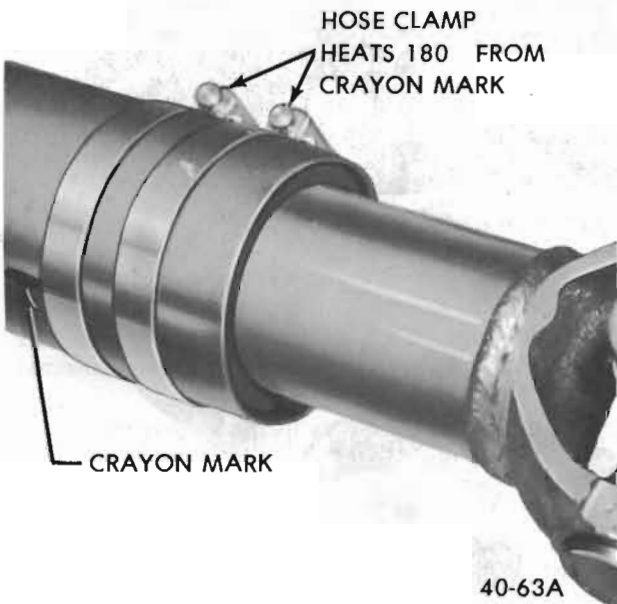
Figure 40-56 - Balance Hose Clamps in Place

3. Install two (2) Wittek type hose clamps on the rear propeller shaft and slide them rearward until the clamps stop at the nearest balance weight welded to the tube. Align both clamps to any one of the four marks made on shaft in Step 2. Tighten the clamps. See Figure 40-56.

CAUTION: Be sure sufficient clearance is maintained so that clamp heads do not contact floor pan of car when axle

is in contact with rebound bumper in frame. In order to gain sufficient clearance, it may be necessary to position the clamps over the balance weights.

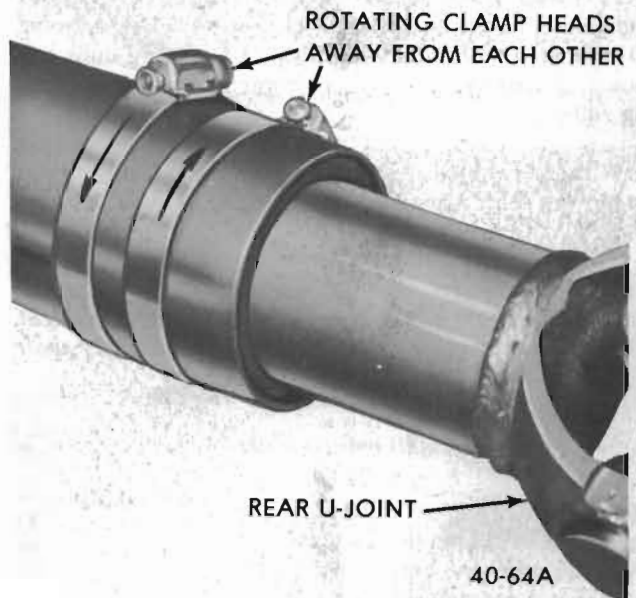
Figure 40-57 - Rotating Balance Hose Clamps

7. Position clamps at point of minimum unbalance. Rotate the clamp heads away from each other 45 degrees. (One each way from the point of minimum unbalance) Run the car and note if unbalance has improved. See Figure 40-57.

In some cases it may be necessary to use one clamp or possibly three clamps in order to obtain a good balance.

8. Continue to rotate the clamps apart in smaller angular increments until the car feel for unbalance is best.

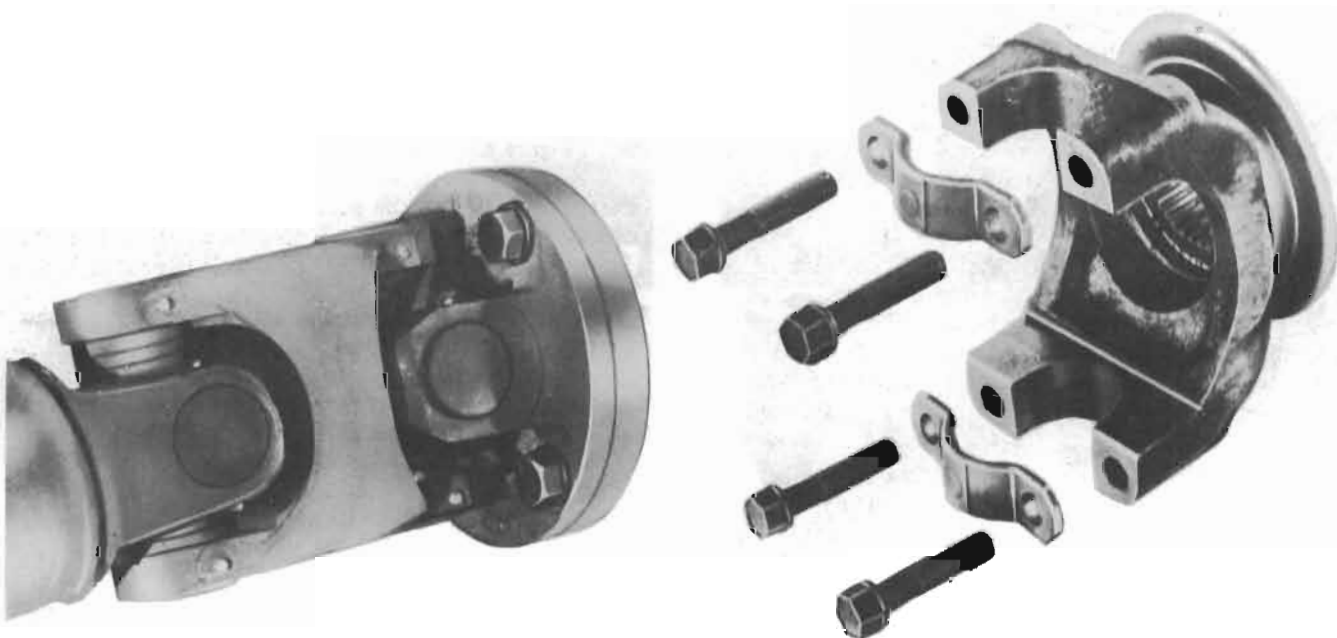
Figure 40-58 - Rear Propeller Shaft Attachments

3. Position rear universal joint to rear axle companion flange, making sure bearings are properly seated in companion flange yoke.

4. Install rear joint fasteners and tighten evenly to torque specified.

NOTE: These propeller shaft to companion flange or end yoke fasteners are important attaching parts in that they may affect the performance of vital components and systems, which may result in major repair expense. They must be replaced with one of the same part number or with an equivalent part, if replacement becomes necessary. Do not use a replacement part of lesser quality or substitute design. Torque values must be used as specified during reassembly to assure proper retention of these parts.

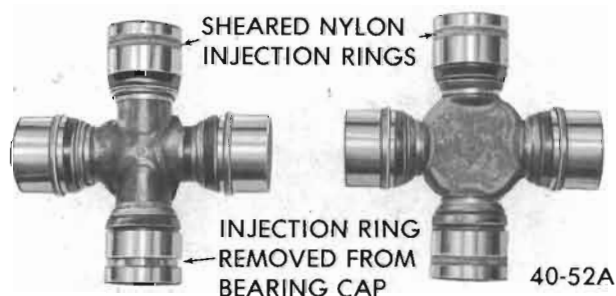
Figure 40-59 - Production Universal Joints

When disassembling a propeller shaft, one or both of the two types of universal joints, as shown in Figure 40-59, may be found.

NOTE: Once a production universal joint is disassembled, it cannot be reassembled as there are no snap ring grooves provided in the bearing cap.

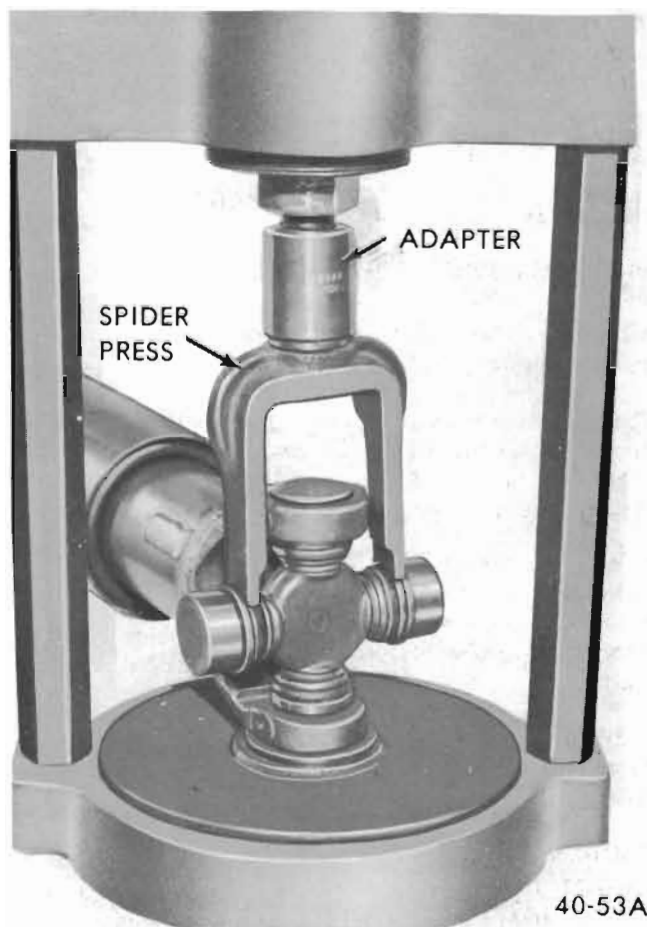
Figure 40-60 - Pressing Out U-Joint Bearing

1. Position propeller shaft and spider press J- 9522-3 in power ram equipped with base plate J-8853 and ram screw adapter J-9522-2. See Figure 40-60.

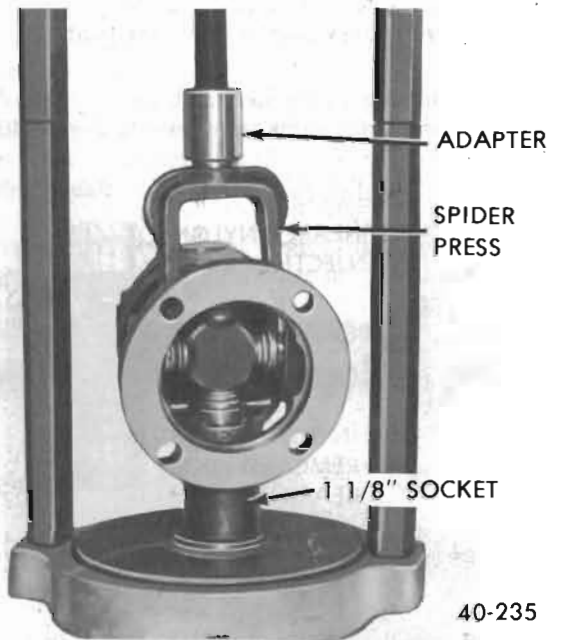
Figure 40-64 Disassembling Rear CV Rear U-Joint

3. Support the propeller shaft horizontally in line with the base plate of a press. Place the rear ear of the coupling yoke over a 1 1/8" socket. Place the spider press (J-9522-3) on the bearing cups in the flange yoke. See Figure 40-64.

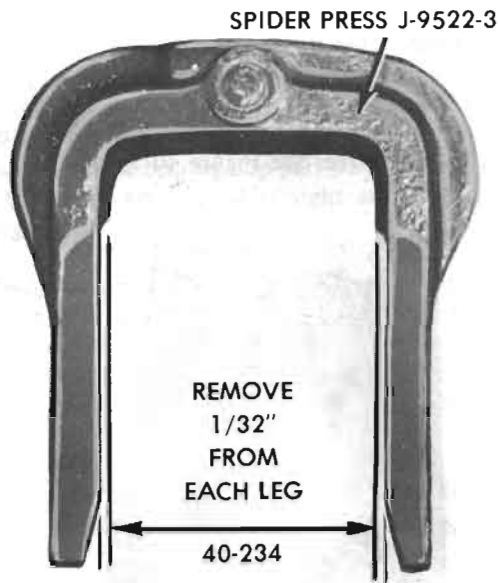
Figure 40-65 Spider Press Leg Rework

NOTE: See Figure 40-65 for rework of older spider presses (J-9522-3) to clear the coupling yoke. Press the bearing cup out of the coupling yoke ear. If the bearing cup is not

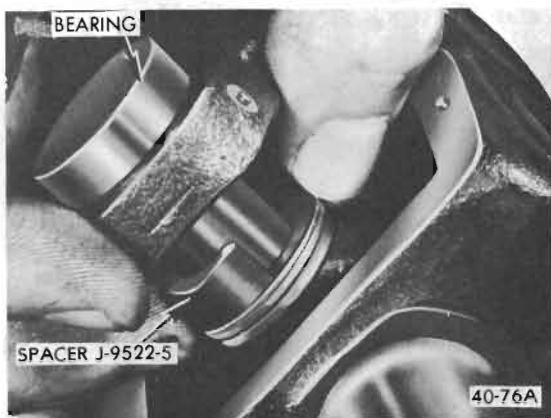
Figure 40-66 Installing Spacer

completely removed, insert spacer (J-9522-5), shown in Figure 40-66, and complete the removal of the bearing cup.

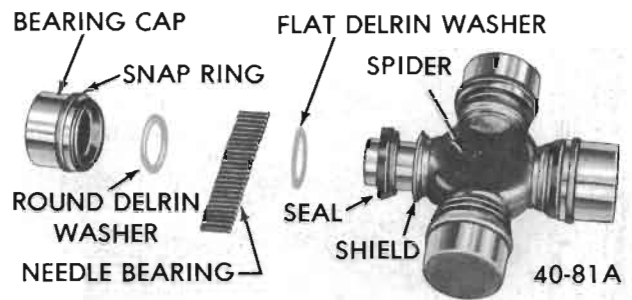
Figure 40-68 - Service Universal Joint

versal joint repair kits. Repair kits are listed in the Buick Master Parts Catalog under Group 5.442 and include a spider, four bearing assemblies, four delrin spacers, four

seals and four shields. The four bearings come equipped with snap rings. See Figure 40-68.

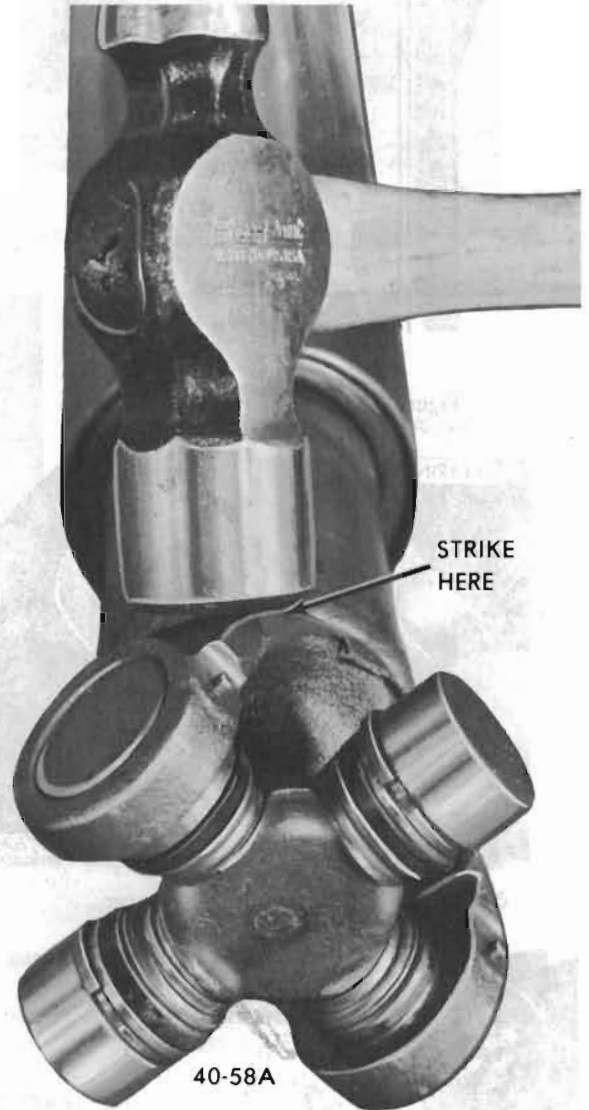
Figure 40-71 Seating U-joint Snap Rings

4. Strike the yoke firmly with a hammer to fully seat the snap rings against the yoke. Turn the spider to make certain that it is free. See Figure 40-71.

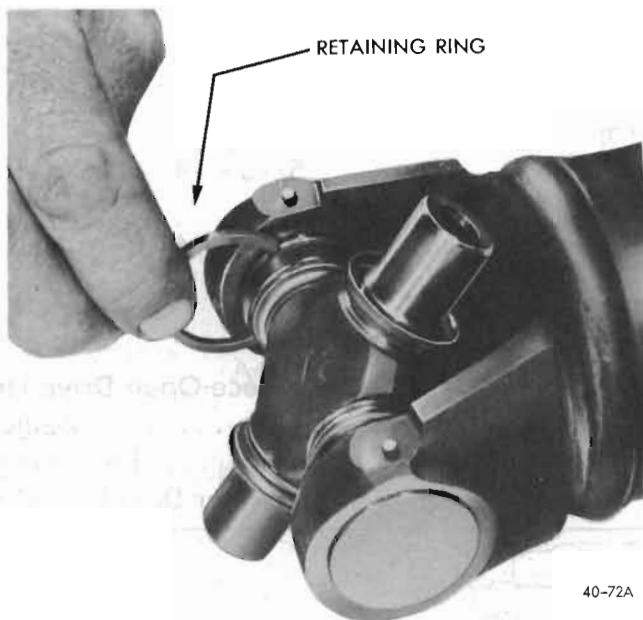
Figure 40-72 Installing Retaining Ring

5. As soon as one snap ring groove clears the inside of the yoke, stop pressing and snap the retaining ring into place. See Figure 40-72.

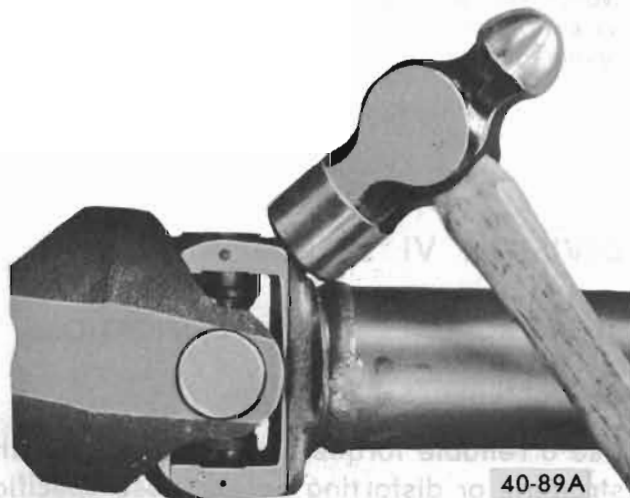
Figure 40-73 Seating Snap Ring

6. Continue to press until the opposite retaining ring can be snapped into place. If difficulty is encountered, strike the yoke sharply with a hammer to aid in seating the rings. See Figure 40-73.

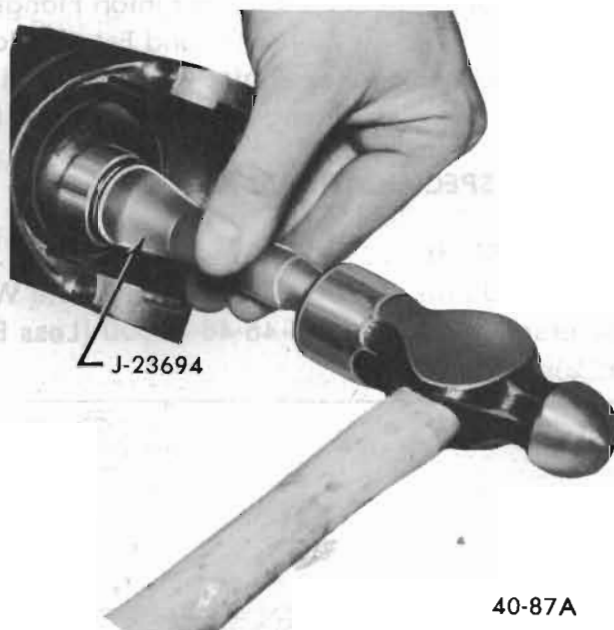
Figure 40-74 Installing Ball Stud Seal

10. Lubricate the seal and press into cavity with Tool J-23694. The sealing lip should tip inward. See Figure 40-74.
